# **South Weymouth Naval Air Station**

## **Geophysical Data Report Electromagnetic, Magnetic, and Seismic Refraction Surveys**

### **FINAL REPORT**

**7 December 2004**

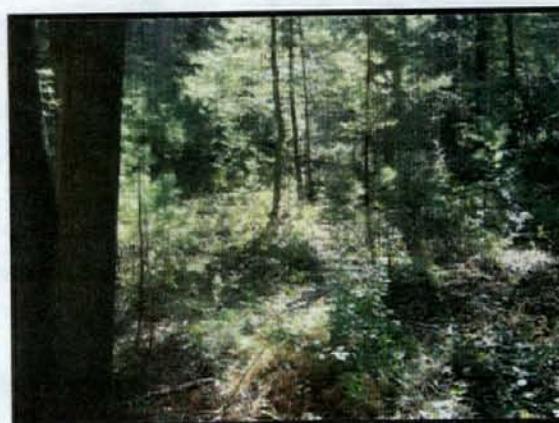
The site is densely vegetated with numerous boulders and fallen trees throughout the site (Image 1). Since the area is designated as wetlands, only minimal vegetation clearance was permitted. An access road in the western portion of the site, with a concrete berm paralleling both sides for a portion of the road, goes southerly from Pigeon Road. There are several large debris piles consisting of concrete footings, fence posts, and other large pieces of metal located northwest of the site.

Image 1: Area of Concern 108 – Former Naval Reserve Bivouac Area.

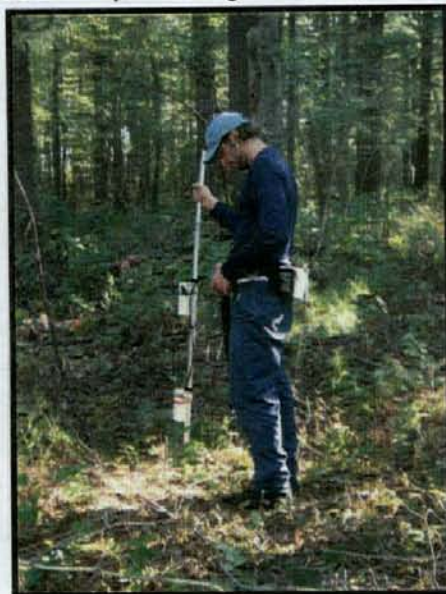
**Image 2:** Vertical gradient measurements were acquired using the Geometrics G858 cesium vapor magnetometer.

The MAG data were collected using a Geometrics 858 cesium vapor magnetometer in the vertical gradient mode (Image 2). The bottom sensor was positioned 8 inches above the ground surface on a staff and a second top sensor was located 2.5 feet from the ground surface directly above the bottom sensor as shown in the image. The collection of magnetic data in vertical gradient mode assists in the discrimination of discrete targets. Sensors closer to the ground are able to pick up smaller shallow objects, but are "noisier" for this reason. An upper sensor provides a means to differentiate the larger anomaly sources. Measurements were acquired at 2.5 foot intervals along survey lines spaced 2.5 feet apart.

A Geometrics G-858G magnetometer was used for this survey. The G-858G, which is an optically pumped cesium vapor instrument, measures the intensity of the earth's magnetic field in nano-Tesla (nT (1 nT = 1gamma)). During operation of the magnetometer, a direct current is used to generate a polarized monochromatic light. Absorption of the light occurs within the naturally precessing cesium atoms found in the instrument's two vapor cells. When absorption is complete, the precessing atoms become a transfer mechanism between light and a transverse radio-frequency (RF) field at a specific frequency of light known as the Larmor frequency. The light intensity is used to monitor the precession and adjusts the RF frequency allowing for the determination of the magnetic field intensity.

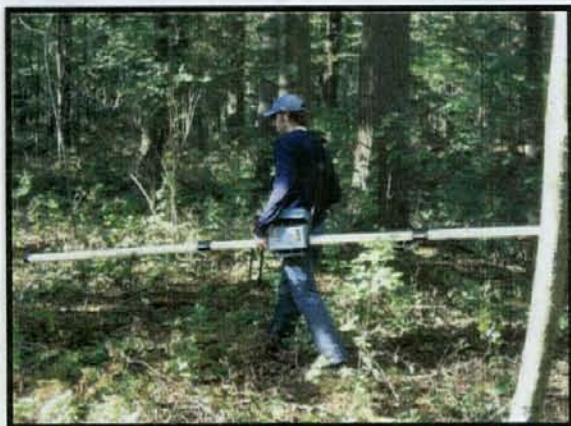
A Geonics EM31 Electromagnetic Terrain Conductivity Meter was used to obtain the EM data (Frequency Domain EM Data). The data were collected in the vertical dipole mode with the transmitter to receiver orientation was parallel to the survey transects (Image 3). This allowed for maneuverability in the dense vegetation encountered at the survey site. EM measurements were acquired every 5 feet along survey lines spaced 5 feet apart.

**Image 3:** Electromagnetic data were obtained at 5 foot sample intervals using the Geonics EM31 electromagnetic terrain conductivity meter.

The EM31 consists of a data logger and 13-foot boom that is carried at the hip of the operator. The data logger is connected by a cable that is attached directly to the EM31 and controls and records data from the instrument. The purpose of the EM31 survey is to detect and evaluate buried ferrous-metallic and non-metallic debris.

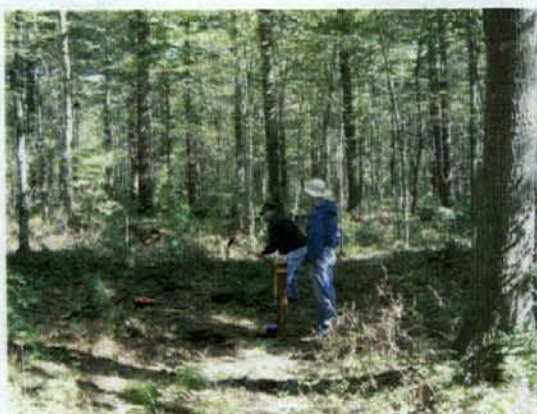
**Image 4:** Area of Concern 108 – Field personnel using sledge hammer for seismic source at a shot point location.

Each seismic spread consisted of 24 geophones located at 5 foot intervals. Five shot points were positioned along each spread. Shot points were positioned 5 foot in-line off each end of each individual spread. Shotpoints were located at the one-quarter and three quarter locations along each spread, as well as at a shotpoint at the center point. A Geometrics StrataView seismograph was used to record the seismic data. Data were recorded digitally and in hard copy form.

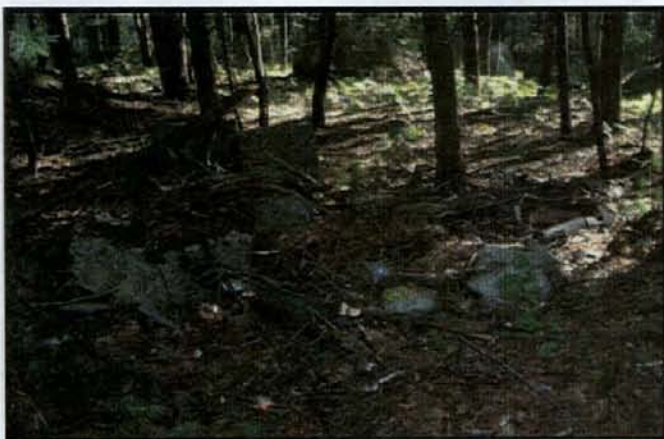
**Image 5:** Culvert beneath access road intersecting with Pigeon Road.

throughout the site. A culvert is present at the intersection of Pigeon Road and the access road to the north (Image 5). Debris piles consisting of metal fence posts, concrete footings, and other types of scrap were encountered to the southeast of the culvert (Targets 14, 15, 21, and 22). A large debris pile, Target 38, is also evident in the northwest central portion of the figures. Data associated with the three monitoring wells are identified as peak responses and are noted on the map. Additional anomalies of varying signal strength and size are seen to be scattered across the site.

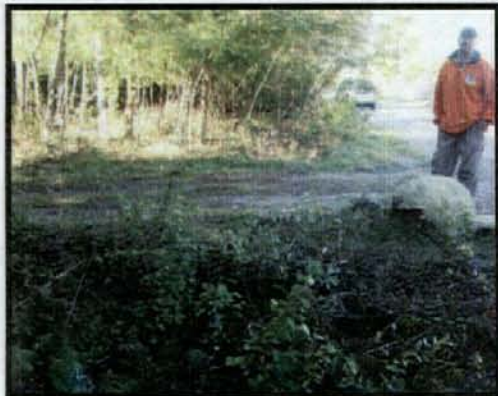
**Image 6:** One of the debris piles located in the northwest central portion of the site.

It can be seen that, aside from the surface debris items as exhibited in Image 6, many of the anomalies encountered are correlated to surface and near-surface metamorphic and igneous boulders. Additional target associations have been made with the concrete berms alongside the road, telephone poles, and other near-surface objects containing metallic components. Some of the extremely low amplitude anomalies as observed in the magnetic data have been correlated to trees and/or

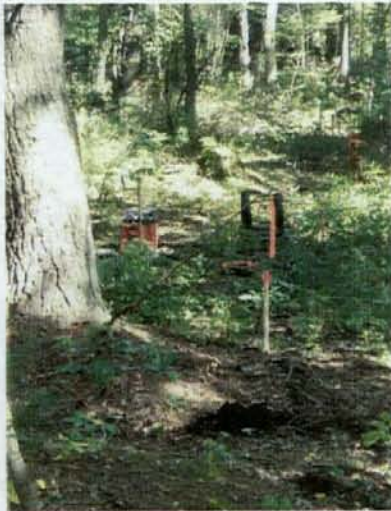
**Image 6:** Picture of Seismic Refraction equipment near monitoring well for calibration of seismic data with well
